#### LINCOLN ELECTRIC EUROPE

Service Notice N°: ESN0076 Rev.0

#### Flow sensor setup-rework instruction

Product	K Number	Code Number	Serial Numbers
Coolarc 26	K14182-1	50444	all serial numbers

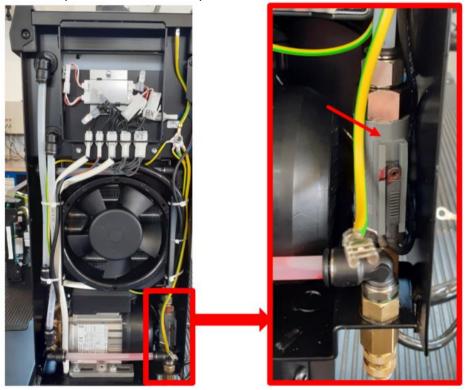
4. Disassembled back panel with marked position of flow sensor:
