Service Notice N°: ESN0074 Rev. 00

Date: 20MAR2019

Elimination of switch off the working machine or no possibility to turn machine on

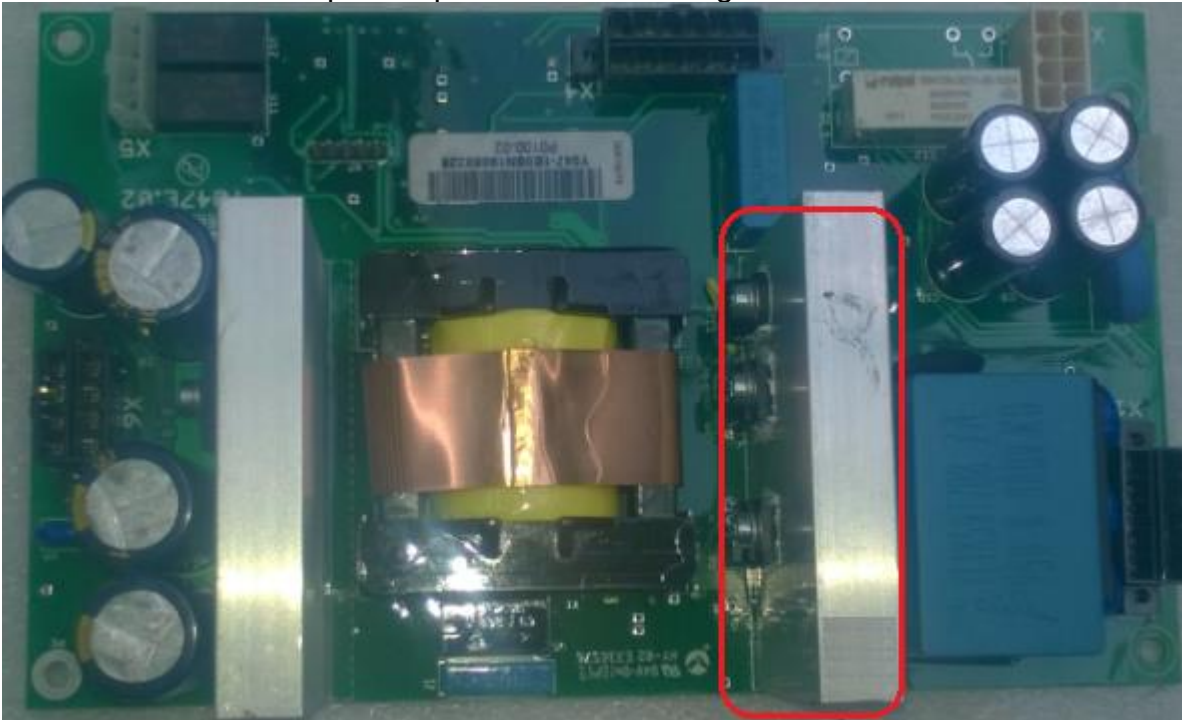
Y047-1

Cause: The Y047 board does not work properly.

Check absence of component placed in red rectangle:

The elimination of this problem can be achieved by ordering and replacing the Y047 board with a proper one. Now, all boards available on the stock are already modified to avoid described problem.

R-6042-081-1R

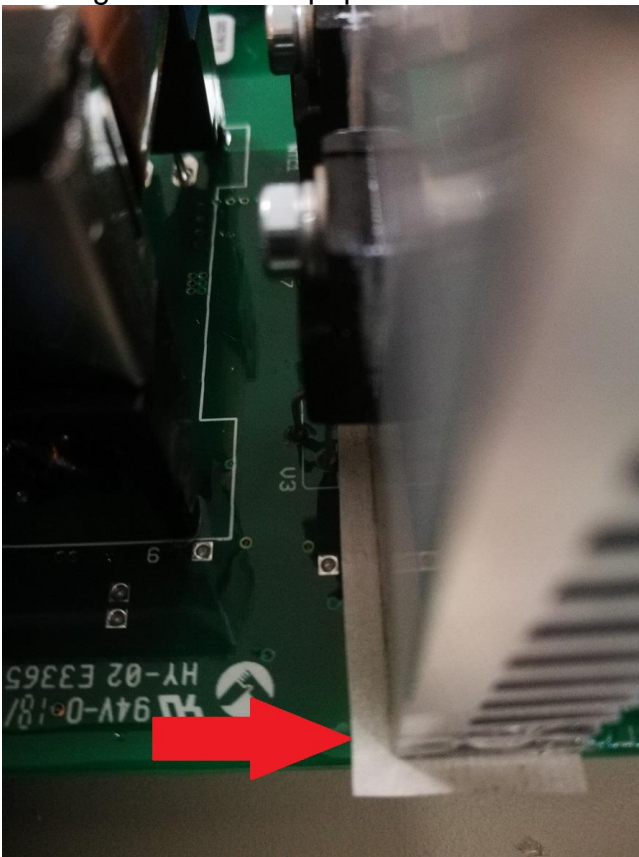
Missing an insulation paper under H1 heatsink:

4. Place two pieces of insulation paper (c.a. Nomex, index NNX0830250 20x5mm, 0,25-0,3mm thickness) under both side of H1 heatsink as is shown on the pictures below:
