Date: 08/12/2008

#2045

**Subject: Potential Electrical Shock Hazard Associated With the Idealarc[®] DC-600
Multi-Process Power Source (Revised 1/29/09)**

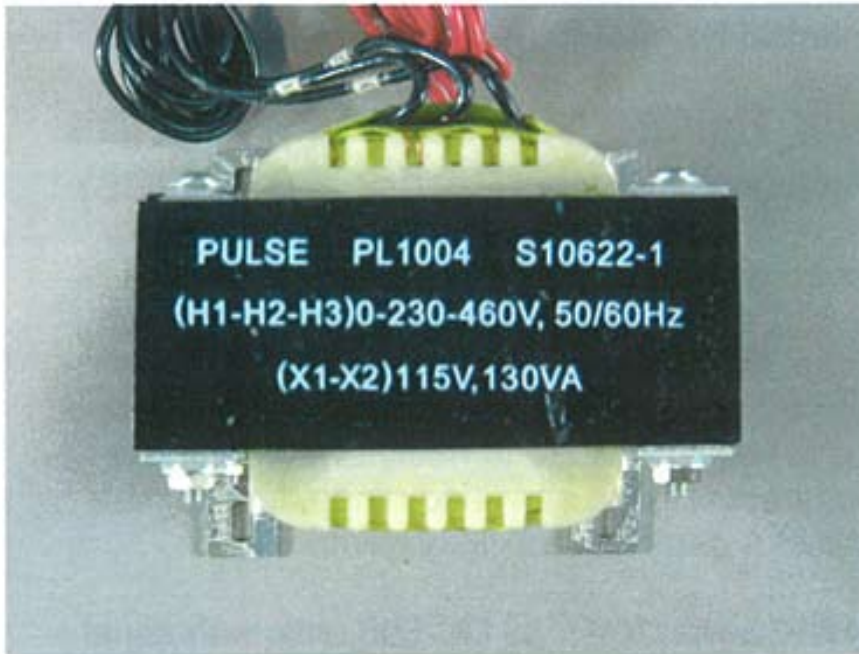
It has come to Lincoln Electric's attention, through an incident that involved an individual receiving an electrical shock while using a DC-600, that failure of an auxiliary transformer can result in the unintended application of voltage to the output terminals when the power switch is in the OFF position. Although the failure of the auxiliary transformer typically does not involve a safety hazard, this Service Notice is being provided to notify customers who have purchased the DC-600, with the serial numbers within a specified range, to eliminate the potential for electric shock due to the failure of a particular auxiliary transformer.

The style of auxiliary transformer that can fail is identified by the designator: PULSE, and may additionally include one of the following designations: PL1004, or PL1005, or PL1007 or PL1008. The photograph below depicts an example of the Pulse auxiliary transformer that needs to be upgraded.

Make arrangements with your local Lincoln Authorized Service Center for the failed auxiliary transformer to be replaced and for a 9SS27504 isolation transformer service kit to be installed.
