LINCOLN ELECTRIC EUROPE

Service Notice N°: ESN0079 Rev.00 Date: 12 October 21

Random shut down of front panel PCB

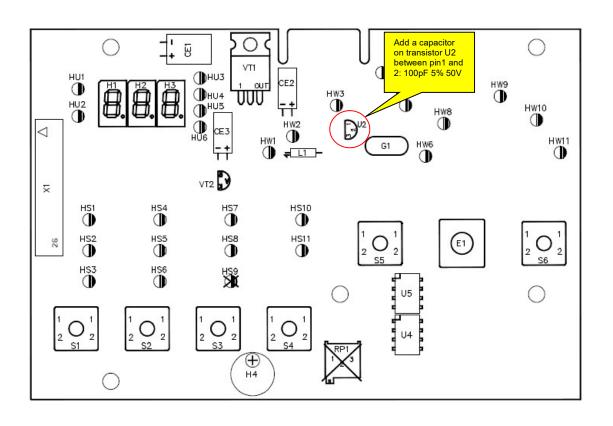
Randomly front panel display shutdown completely even if the recommendations listed into the ESN0078 have been applied

Problem can be solved by adding a capacitor on PCB control panel
