Service Notice Number: 20200910-2

Date: 9/15/2020

Increased Risk of Error 82 on LN-25X and ACTIV8X

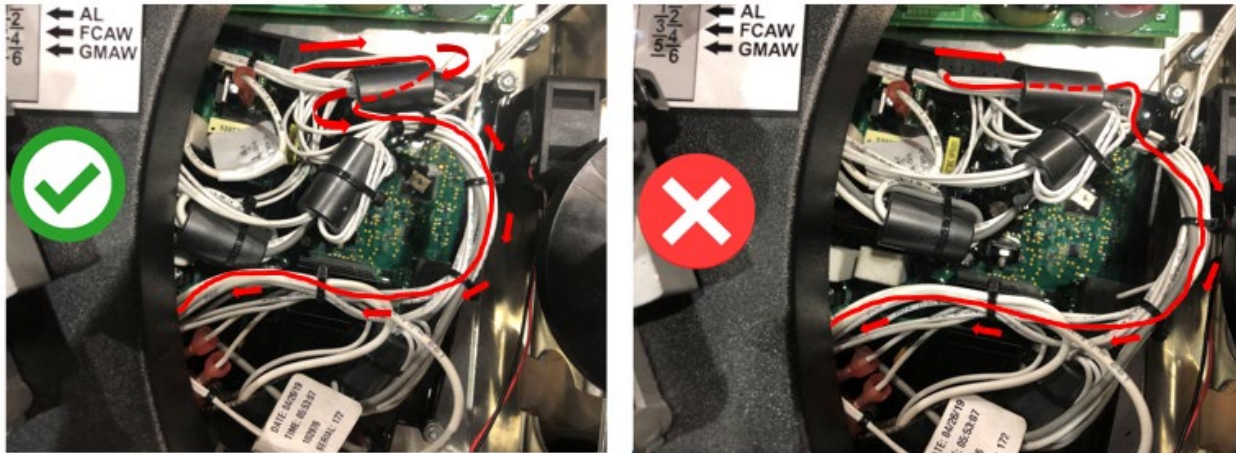
LN-25X and ACTIVE8X feeders may experience a higher risk of Error 82 due to electrical noise.

LN-25X: Lead 707 being rerouted thru toroid. Direction arrows show routing from flexible power pc board to user interface pc board.

- A Molex removal tool is required for this repair (Molex Mini Fit 11-03-0044).
- Remove the wire drive assembly and control box cover to access the flexible power pc board.
- Locate wire lead 707 and disconnect it from the P6 Molex pin 8 using the Molex removal tool (note, the locking post needs to be removed first).
- Reroute wire lead 707 through the toroid containing the P1 leads 510, 511, 512, 513, 517, 518, 519. The direction does matter. See illustration of the correct routing below.

- Reconnect the wire lead 707 to the P6 Molex pin 8 and reinsert locking post.

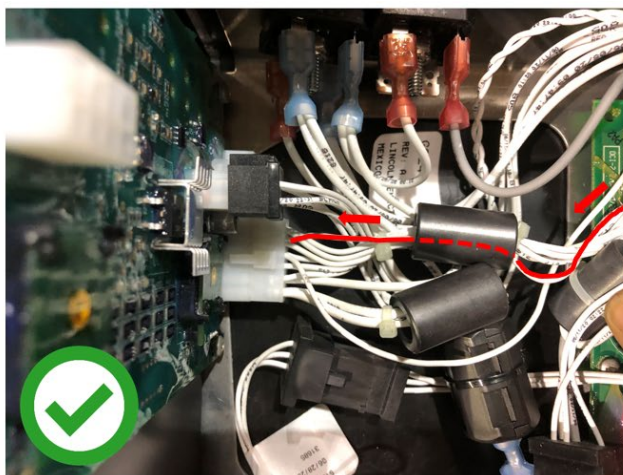
Activ8X: Lead 707 being rerouted thru toroid. Direction arrows show routing from flexible power pc board to user interface pc board.

- A Molex removal tool is required for this repair (Molex Mini Fit 11-03-0044).
- Remove the case front assembly to access the user interface pc board.
- Locate the wire lead 707 and disconnect it from the J31 Molex pin 2 using the Molex removal tool.
- Reroute the wire lead 707 through the toroid (1 pass) in the same direction as the other leads in located in P31. The direction does matter.
- Reconnect the wire lead 707 to the P31 Molex pin 2 (Correct routing shown below).
