LINCOLN ELECTRIC EUROPE

Service Notice N°: ESN0078 Rev.01

Random shut down of front panel PCB

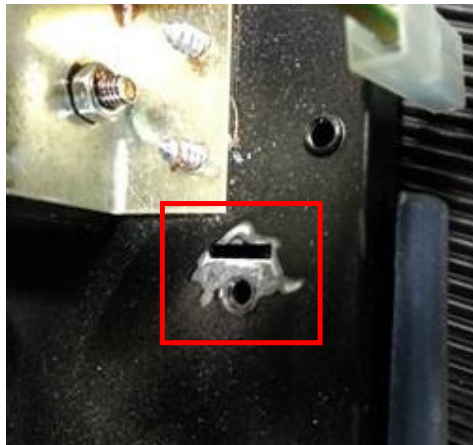
Randomly, after starting or during welding, the front panel turns off completely and the welding arc is extinguished

1. Remove the machine cover.
2. Locate all earth/ground connectors fixed on the machine metal frame
3. Remove the earth/ground wires from the connectors
4. Remove the earth/ground connectors from the machine metal frame and remove the paint that is present between the connector and the frame as shown into the below picture

5. Reinstall the earth/ground connectors to the machine metal frame
6. Connect again all the earth/ground wires to the connectors.
7. Close the machine with the cover.

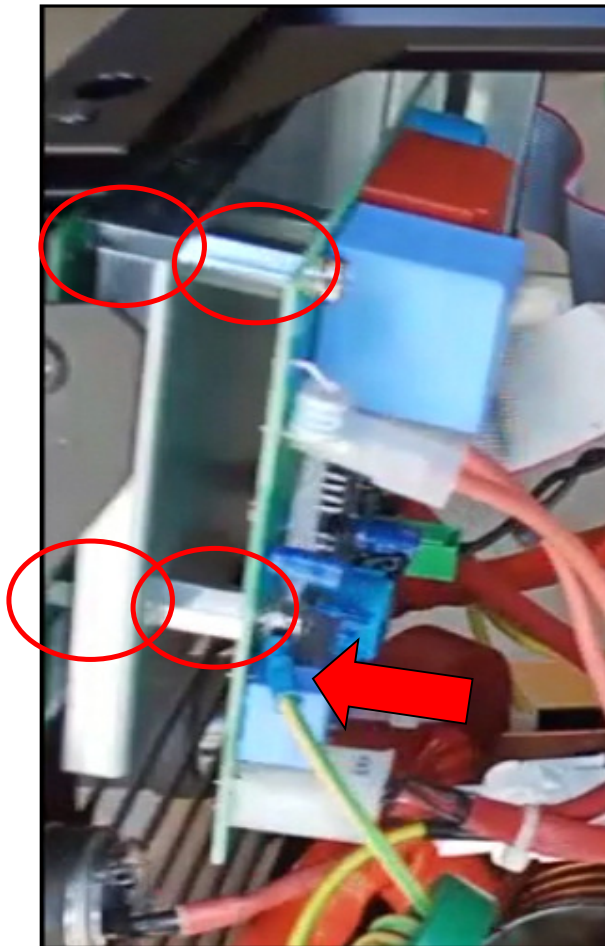
Correction of the Problem for Invertec 175TP (K14169-1) 7 wrong metal standoff

1. Remove the machine cover.
2. Locate the HF PCB and the Control Panel PCB mounted on the back of the machine front panel (the following picture is showing you the four standoff on the left side, three more are on the right side)

3. Remove the 3 screws that are fixing the HF PCB to the machine and remove the HF PCB from the machine.
4. Remove the 3 metal stands off and the metal plate.
5. Remove the 4 stands off that are fixing the Control Panel PCB and replace them with 4 plastic ones type: M4x15 M/F HEX NYLON - W8604080
6. Reassembly the metal plate, the 3 plastic stands off and the HF PCB, paying attention to connect again the earth cable (indicated by the red arrow into the above picture)
7. If you are not able to find the plastic stands off in your local market, please ask to send some to your attention to Lukasz Wardencki
