LINCOLN ELECTRIC EUROPE

Service Notice N°: ESN0050 Rev. 0

Date: 13 JULY 10

Invertec 270sx & 400sx and Tomahawk 1025 & 1538 Fuse substitution

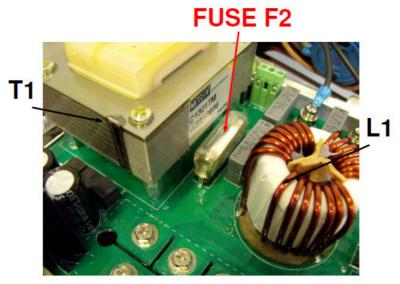
Input boards W05X0855-1 and 2 of these machine mount a 1.6A delayed fuse (F2). When the fan fails, shorting itself, the fuse doesn't blow up on due time. This problem carries the transformer T1 to fail.

The fuse F2 is suited between the transformer T1 and the EMC inductance L1 on input board.

For units with serial number below **I2100602462**, fuse must be substitute by a 0.5A delayed fuse (LEI code: W7300500R) so that the transformer is protected when fan shorts circuit happen.
