Weartech® SHS™ Thermal Spray Coating on Boiler Tubes

Provides Superior Erosion and Corrosion Resistance

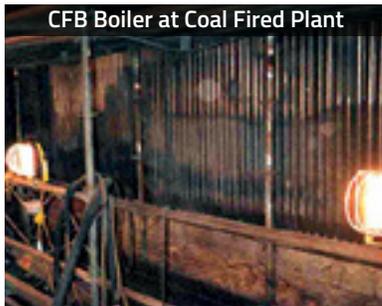
Field trial conducted on boiler tube section where most severe erosion damage occurs.

Inside a CFB boiler at a coal fired power plant in Pennsylvania, a thermal spray coating field trial comparison was conducted on a section of boiler tubes where the most severe erosion damage occurs. Wearthech® SHS™7170 WTWAS was applied to a 7 x 5 ft. (2.1 x 1.5 m) section of boiler tubes between two LMC Armacor™ thermal spray coatings of equal size.

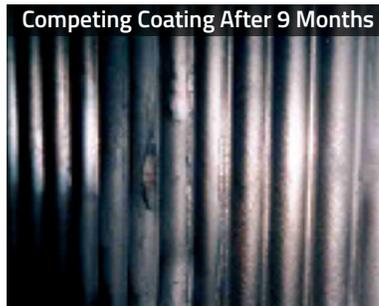
Competitors coating shows damage from erosion requiring repair.

When the boiler tubes were inspected during a scheduled outage after 9 months of service, the Wearthech SHS7170 WTWAS coating did not show any signs of erosion or corrosion damage while competitor coatings showed erosion damage requiring repair.

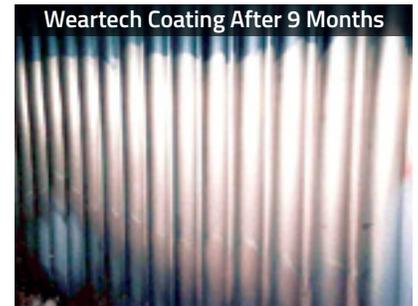
Wearthech SHS7170 WTWAS coating shows no erosion or corrosion damage.
