Weartech® SHS™ Coating and Overlay Wear Plate

Extend Rotary Vane Feeder Drum Life by 200%

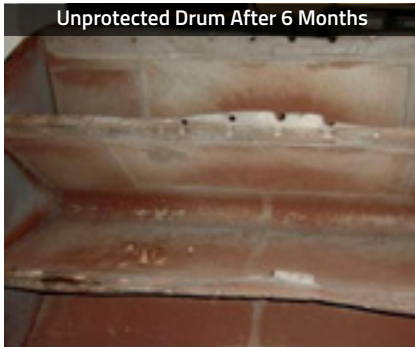
Vane pockets on a rotating drum inside the rotary vane feeder are fabricated from unprotected steel and not sufficiently resistant to sliding abrasion, fine particle erosion and corrosion. During service, surface material loss on the vane pockets from wear and corrosion is severe and the drum requires replacement after 6 months.

Vane pockets are damaged by wear and corrosion and must be replaced.

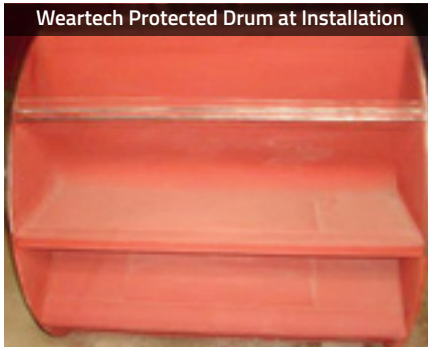
Weartech overlay wear plate and thermal spray coating are for resisting wear and corrosion.

To extend the life of rotary vane feeder drums at a cement plant in South America, Weartech® SHS™9192U wear plate, 0.748 in (19 mm) thickness, is installed in the center of each vane pocket for abrasion and impact resistance. A Weartech SHS7170 WTWAS coating, 0.039 in (1 mm) thickness, is applied to the wear plate and remaining drum surface for wear and corrosion resistance.

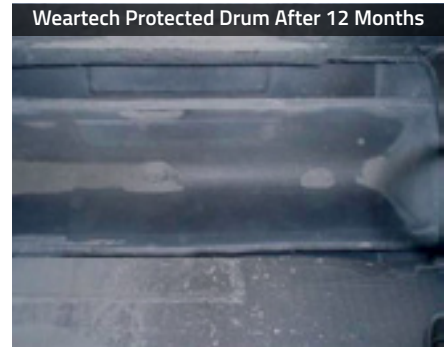
Vane pockets show minimal wear and no corrosion damage.

After 6 months of service, the unprotected drum suffered significant wear and corrosion damage and required replacement. An inspection after 12 months, the drum protected by Weartech SHS showed minimal material loss from surface wear to be 0.059 in (1.5 mm) and no corrosion damage.
